**Flood Control Project Maintenance  
Levee Inspections**  
**LMA District Cover Sheet**  
**Spring 2018 Levee Inspection Results**

**City of Sacramento**

**Spring 2018 Levee Inspection Results**

Waterway			Bank	Unit Miles
Unit No. 01 Sacramento River			Left	3.67
	Spring (March - May)	Summer (June - August)	(September - November) Fall	Winter (December - February)
Unit Maintenance Rating (Fall Only)				
Date of Inspection	3/20/2018 - 3/20/2018			
DWR Inspector	Zach Jojola			
Accompanied By	Adam Strebel City of Sacramento

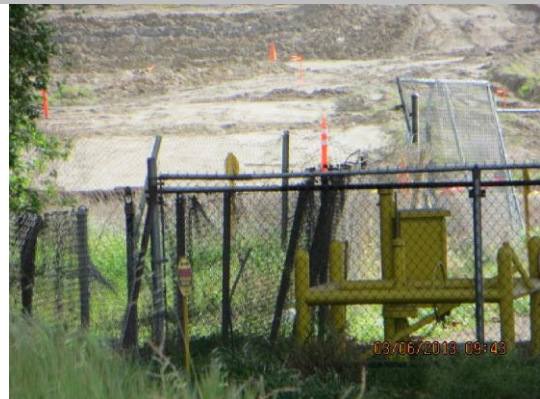
Photo 2 of 3 : UCIP\_SP\_2018\_49955\_33805.jpg

View of multiple markers indicating gas alignment.

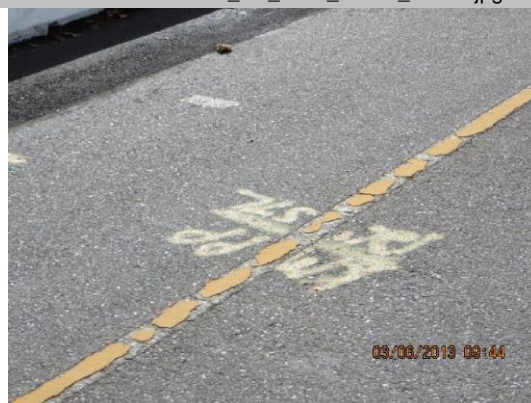
Photo 3 of 3 : UCIP\_SP\_2018\_49955\_33807.jpg

Underground service alert (USA) markings indicate 12 inch crossing through levee.

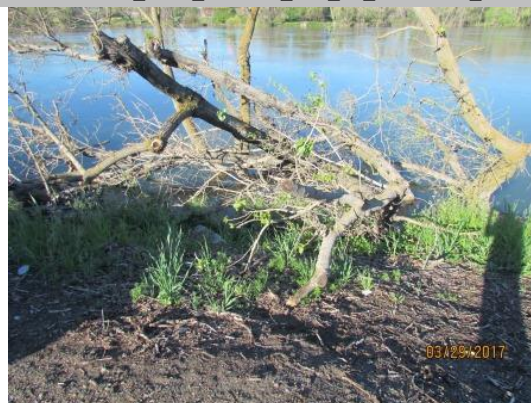
Photo 1 of 1 : SP\_2018\_NA0005\_251\_79\_20180319\_00016.jpg

LM Start	0.08	Rating **	M	Issue No.	79
LM End	0.08	Issue Type +	Ma	Location *	WS
Category	Earthen Levee			GPS Latitude/Longitude	
				Start	End
Item	Encroachments			38.589690 °	38.589690 °
				-121.505106 °	-121.505106 °
DWR ID	DWR_NA0005_01_s_2017_79				
Comment Code					
TR : Tree or limb					
Inspector Comment					
Tree limbs on waterside slope.

Fallen tree limbs on the waterside levee slope, looking toward the Sacramento River. Spring 2017.

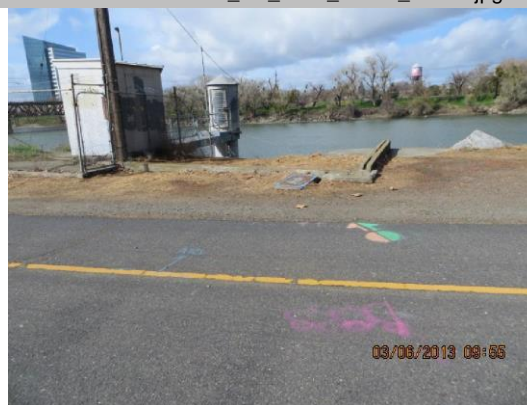
Photo 2 of 3 : UCIP\_SP\_2018\_41414\_72621.jpg

Underground Service Alert (USA) markings indicating 42 inch line through levee.

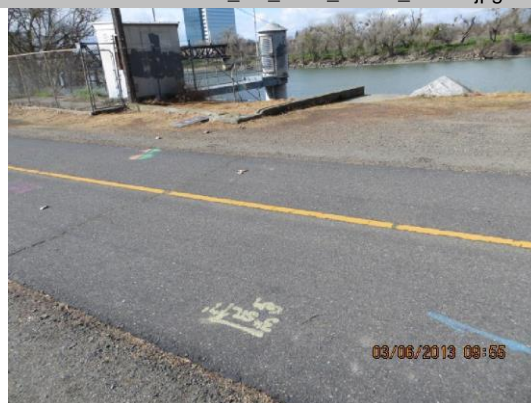
Photo 1 of 2 : UCIP\_SP\_2018\_41415\_72630.jpg

LM Start	0.14	Rating **	M	Issue No.	100
LM End	0.14	Issue Type +	En	Location *	
Category	Supplemental			GPS Latitude/Longitude	
				Start	End
Item	DWR UCIP Field Study			38.588738 °	38.588738 °
				-121.504891 °	-121.504891 °
DWR ID					
Comment Code					
Inspector Comment					
FS_ID:41415 DS_ID:24883 EP_NO: N/A Repair Type: Non-Urgent Crossing Status: Indicator Found UCIP Comments: 07/21/2016 Meet with City of Sacramento North Area Drainage representatives: Mick Smith and Mike Gonsalves. No Additional information was made available regarding the fate of this crossing. (DWR UCIP – O. Magana) 03/06/2013 Need to contact owner to confirm alignment and status of crossings. No permit found during desk study review. (DWR UCIP - O. Magana) FIELD_STRUCT_DESC: ARV communication line and 3-inch steel communication line through levee at unknown depth below the levee crown. FS Date: 3/6/2013

Underground Service Alert (USA) markers visible on levee crown.

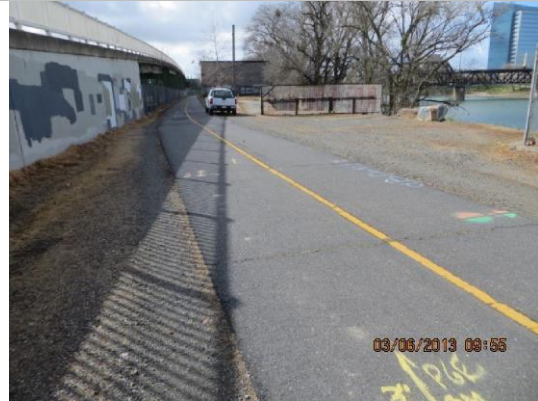
Photo 1 of 3 : UCIP\_SP\_2018\_52599\_72627.jpg

View of levee crown and alignment of PG&E line visible by yellow paint markings.

07/19/2016 same as previous inspection. Need to contact owner to determine status of crossing. Unable to confirm alignment or depth through the levee crown. (DWR UCIP - omagana)10/17/2014 No markers found. Need to contact owner to determine status of crossing and to determine last inspection date. (DWR UCIP - omagana)  
FIELD\_STRUCT\_DESC: 3-inch steel gas line though levee at unknown depth. Underground alert service (USA) markings indicate this line is a PG&E line (USA markings visible in 2013). In case of an emergency related to this crossing PG&E has identified the following contact: PG&E's local pipeline engineer, Mike Aronoff, at (916) 307-9472 (cell) and Gas Control (North) 800-442-4743. For non-emergency issues please contact the local PG&E Gas Pipeline Operations & Maintenance (GPOM) Supervisors for the Sacramento region, David Wade at (209) 639-1039 (cell) or Ron Hicks at (916) 396-9038 (cell).

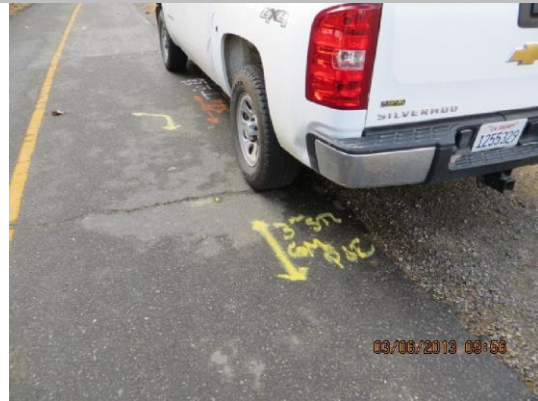
Photo 2 of 3 : UCIP\_SP\_2018\_52599\_72626.jpg

Underground Service Alert (USA) markings of PG&E line through levee, Photo 1 of 2.

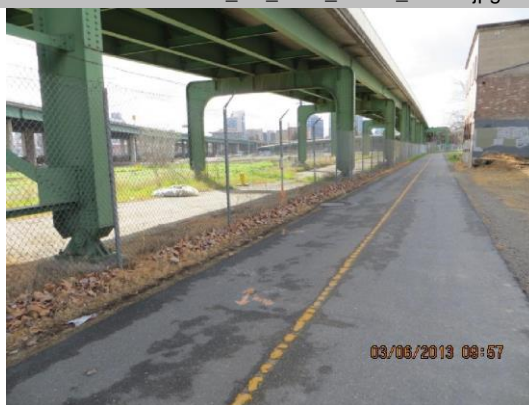
Photo 2 of 2 : UCIP\_SP\_2018\_41416\_72628.jpg

Alignment of communication line through levee, Photo 2 of 2.

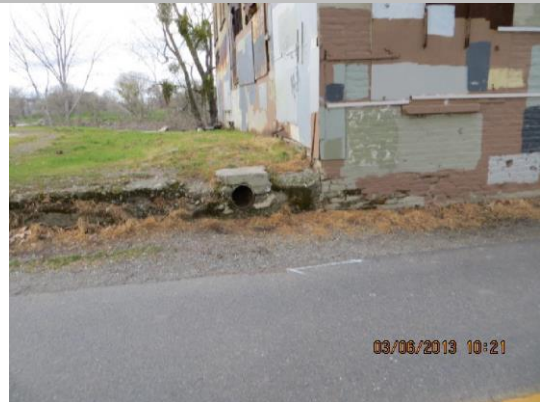
Photo 1 of 3 : UCIP\_SP\_2018\_40848\_72633.jpg

LM Start	0.22	Rating **	M	Issue No.	104
LM End	0.22	Issue Type +	En	Location *	
Category	Supplemental			GPS Latitude/Longitude	
				Start	End
Item	DWR UCIP Field Study			38.587615 °	38.587615 °
				-121.505034 °	-121.505034 °
DWR ID					
Comment Code					
Inspector Comment					
FS_ID:40848 DS_ID:24887 EP_NO: N/A Repair Type: Non-Urgent Crossing Status: Indicator Found UCIP Comments: 07/21/2016 Meet with City of Sacramento North Area Drainage representatives: Mick Smith and Mike Gonsalves. Pipe is installed above crown. (DWR UCIP – O. Magana) 03/06/2013 Pump station appears non-functional. Owner will need to coordinate with DWR-Inspector and CVFPB to determine if crossing meets Title 23 requirements. (DWR UCIP - O. Magana) FIELD_STRUCT_DESC: 12-inch steel drainage pipe connected to 10 inch pipe through levee at unknown depth. FS Date: 3/6/2013

Pipe through levee visible next to building located on levee.

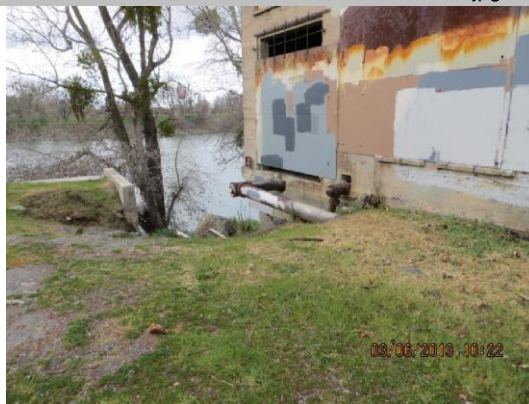
Photo 3 of 3 : UCIP\_SP\_2018\_40848\_72631.jpg

View of building and additional concrete structures located on levee crown at waterward side.

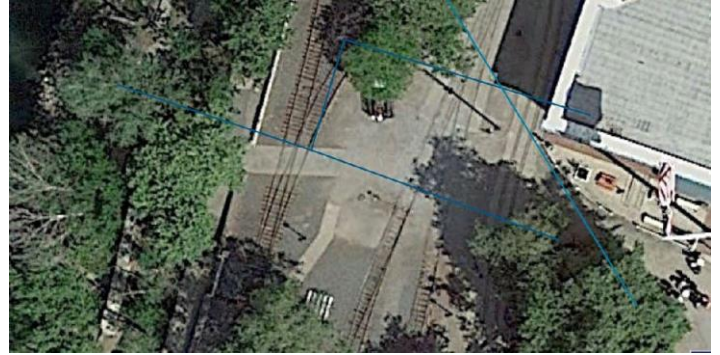
Photo 1 of 1 : UCIP\_SP\_2018\_41247\_72740.jpg

Alignment provided by City of Sacramento of 10 inch line--not found during field inspection.

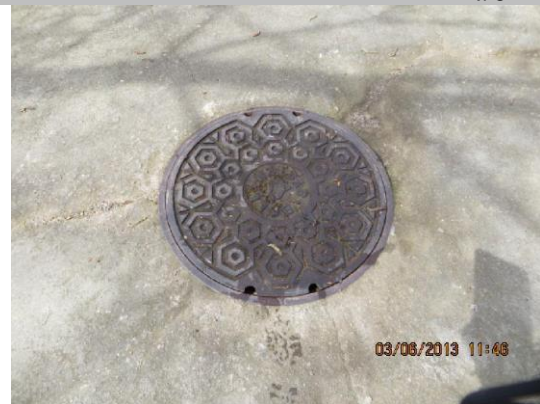
Photo 1 of 3 : UCIP\_SP\_2018\_41417\_72642.jpg

PacBell manhole located on waterward side.

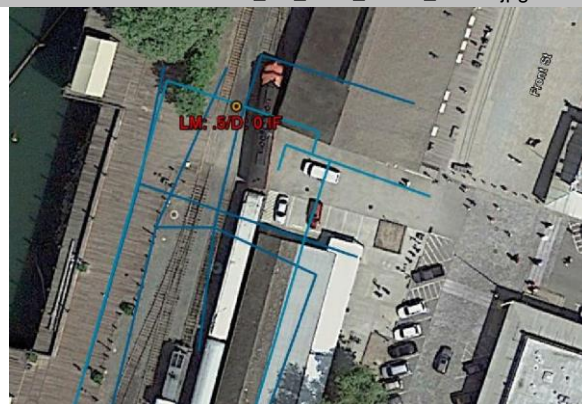
Photo 1 of 1 : UCIP\_SP\_2018\_41418\_72741.jpg

Aproximate alignment provided by City of Sacramento -- unable to confirm if crossing is active.

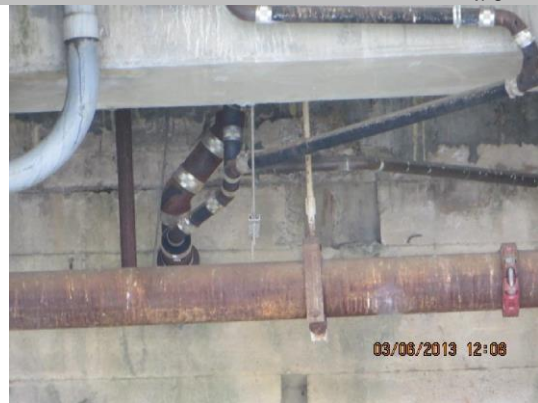
Photo 1 of 1 : UCIP\_SP\_2018\_41260\_72743.jpg

Conduit through floodwall.

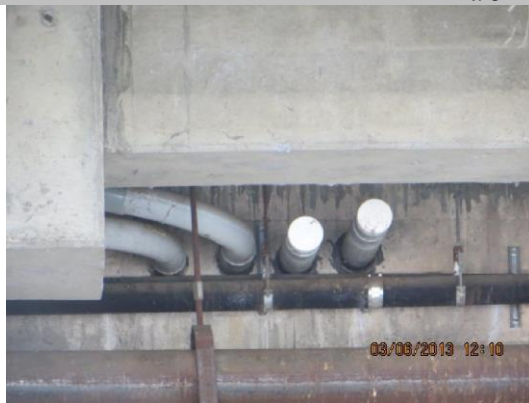
Photo 1 of 1 : UCIP\_SP\_2018\_41420\_72746.jpg

View of conduits through floodwall visible from waterward side.

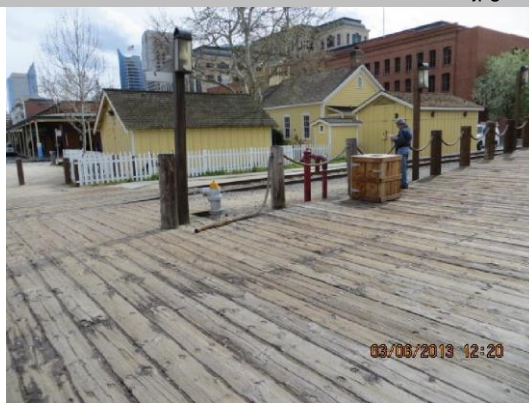
Photo 1 of 1 : UCIP\_SP\_2018\_41266\_72747.jpg

Fire hydrant visible on levee crown.

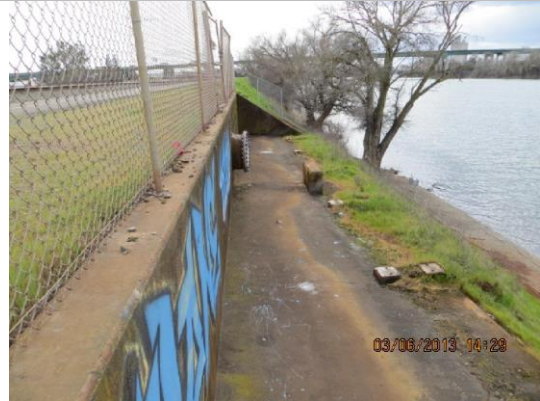
Photo 2 of 3 : UCIP\_SP\_2018\_41425\_34144.jpg

Headwall with 1 crossing capped off.

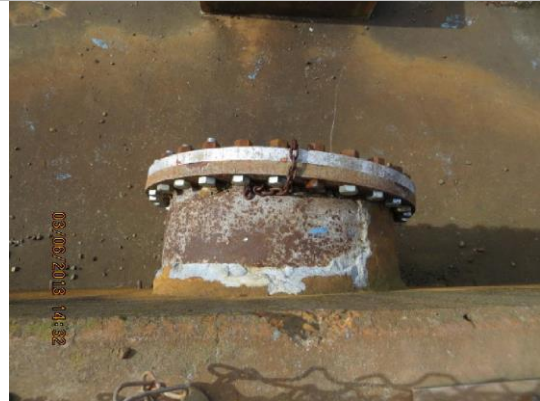
Photo 3 of 3 : UCIP\_SP\_2018\_41425\_34143.jpg

Metal plate used to cap off pipe.

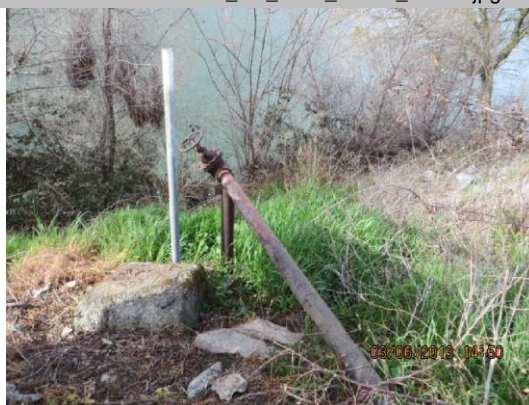
Photo 2 of 2 : UCIP\_SP\_2018\_49767\_34066.jpg

View of pipe and gate valve located on waterward slope.

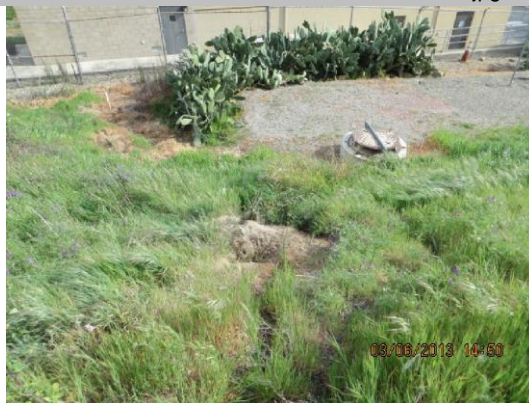
Photo 2 of 3 : UCIP\_SP\_2018\_49957\_34072.jpg

View of landward side--tall grass along slope limit inspection.

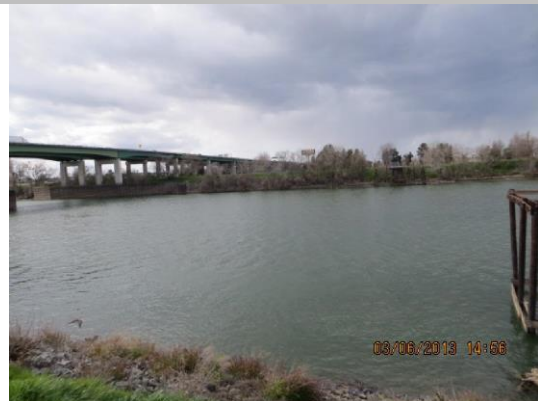
Photo 2 of 3 : UCIP\_SP\_2018\_49958\_34050.jpg

View of waterward side--outlet submerged.

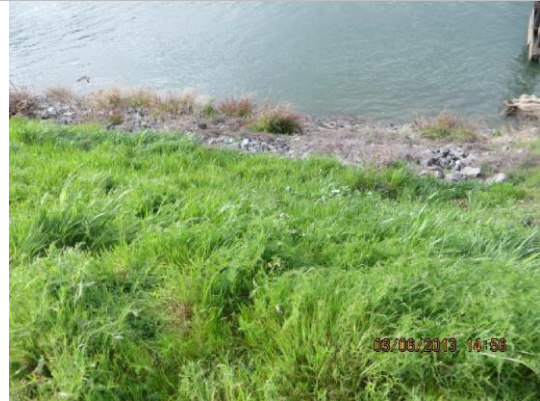
Photo 3 of 3 : UCIP\_SP\_2018\_49958\_34049.jpg

Tall grass along pipe alignment--limited inspection.

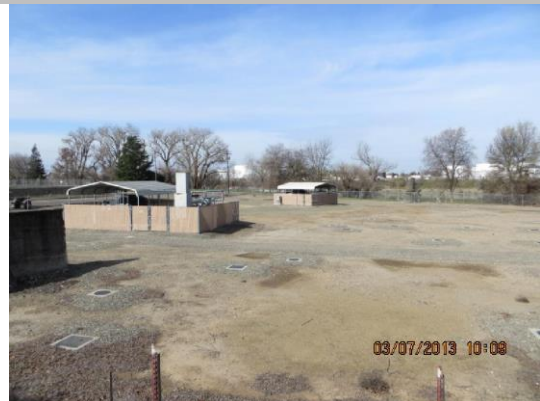
Photo 2 of 3 : UCIP\_SP\_2018\_41282\_59574.jpg

Several vapor wells present inside fenced area.

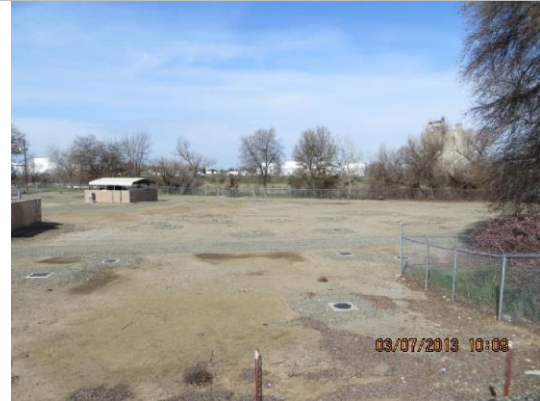
Photo 3 of 3 : UCIP\_SP\_2018\_41282\_59573.jpg

More vapor wells present on levee crown.

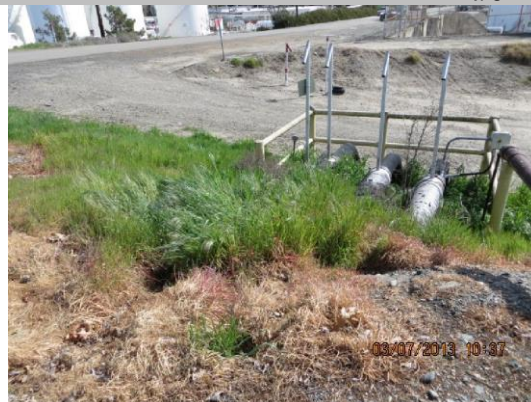
Photo 2 of 3 : UCIP\_SP\_2018\_41452\_59524.jpg

Dense burrow activity along landward slope.

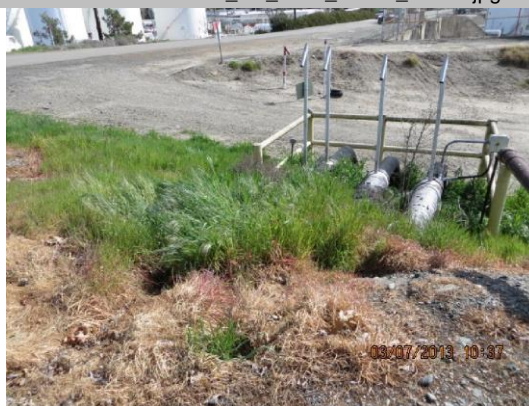
Photo 3 of 3 : UCIP\_SP\_2018\_41448\_59512.jpg

Dense vegetation and large burrow holes located on shoulder.

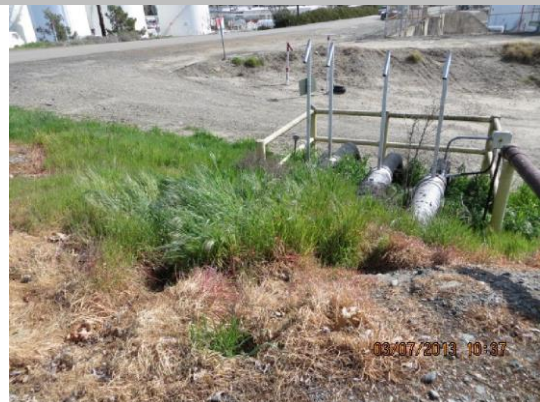
Photo 2 of 3 : UCIP\_SP\_2018\_48322\_59520.jpg

Dense burrow activity along levee slope.

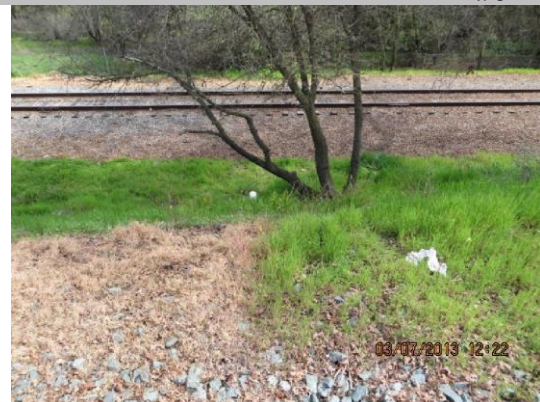
Photo 1 of 2 : UCIP\_SP\_2018\_41293\_72760.jpg

PVC pipe through levee.

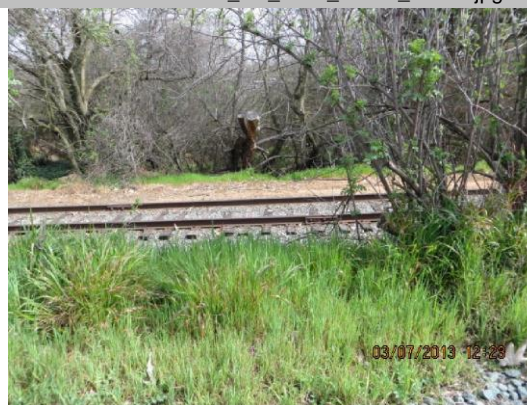
Photo 2 of 2 : UCIP\_SP\_2018\_41295\_72763.jpg

Dense vegetation along landward slope.

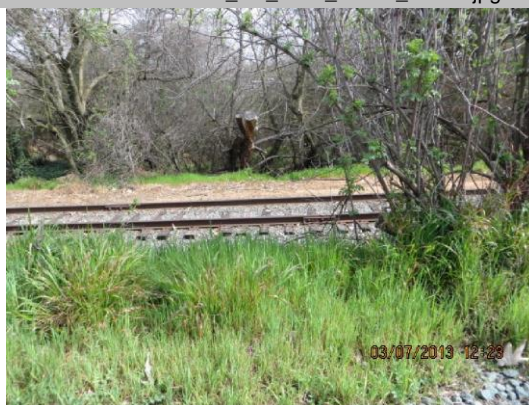
Photo 2 of 2 : UCIP\_SP\_2018\_38827\_72765.jpg

Dense vegetation on landward side.

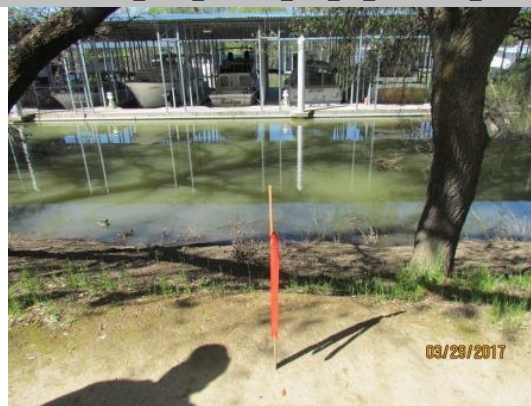
Photo 1 of 1 : SP\_2018\_NA0005\_251\_86\_20180319\_00022.jpg

LM Start	2.16	Rating **	A/W	Issue No.	86
LM End	2.16	Issue Type +	Ma	Location *	WS
Category	Earthen Levee			GPS Latitude/Longitude	
				Start	End
Item	Erosion / Bank Caving			38.562024 °	38.562024 °
				-121.515923 °	-121.515923 °
DWR ID	DWR_NA0005_01_s_2017_86				
Comment Code					
E1 : Note and monitor erosion site.					
Inspector Comment					
Erosion on wateside slope. Marked on March 17, 2017

Erosion on wateside slope that appers to be underwater. Marked on March 17, 2017. Spring 2017.

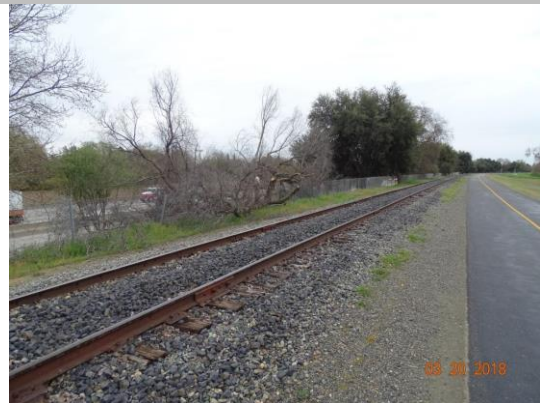
Photo 1 of 1 : SP\_2018\_NA0005\_251\_77\_20180320\_00125.jpg

View of fallen tree on landside slope. Spring 2018.
